The Effectiveness of Flexible Base Cushion Courses Over Old Pavements

January 1966

State of California
Highway Transportation Agency
Department of Public Works
Division of Highways

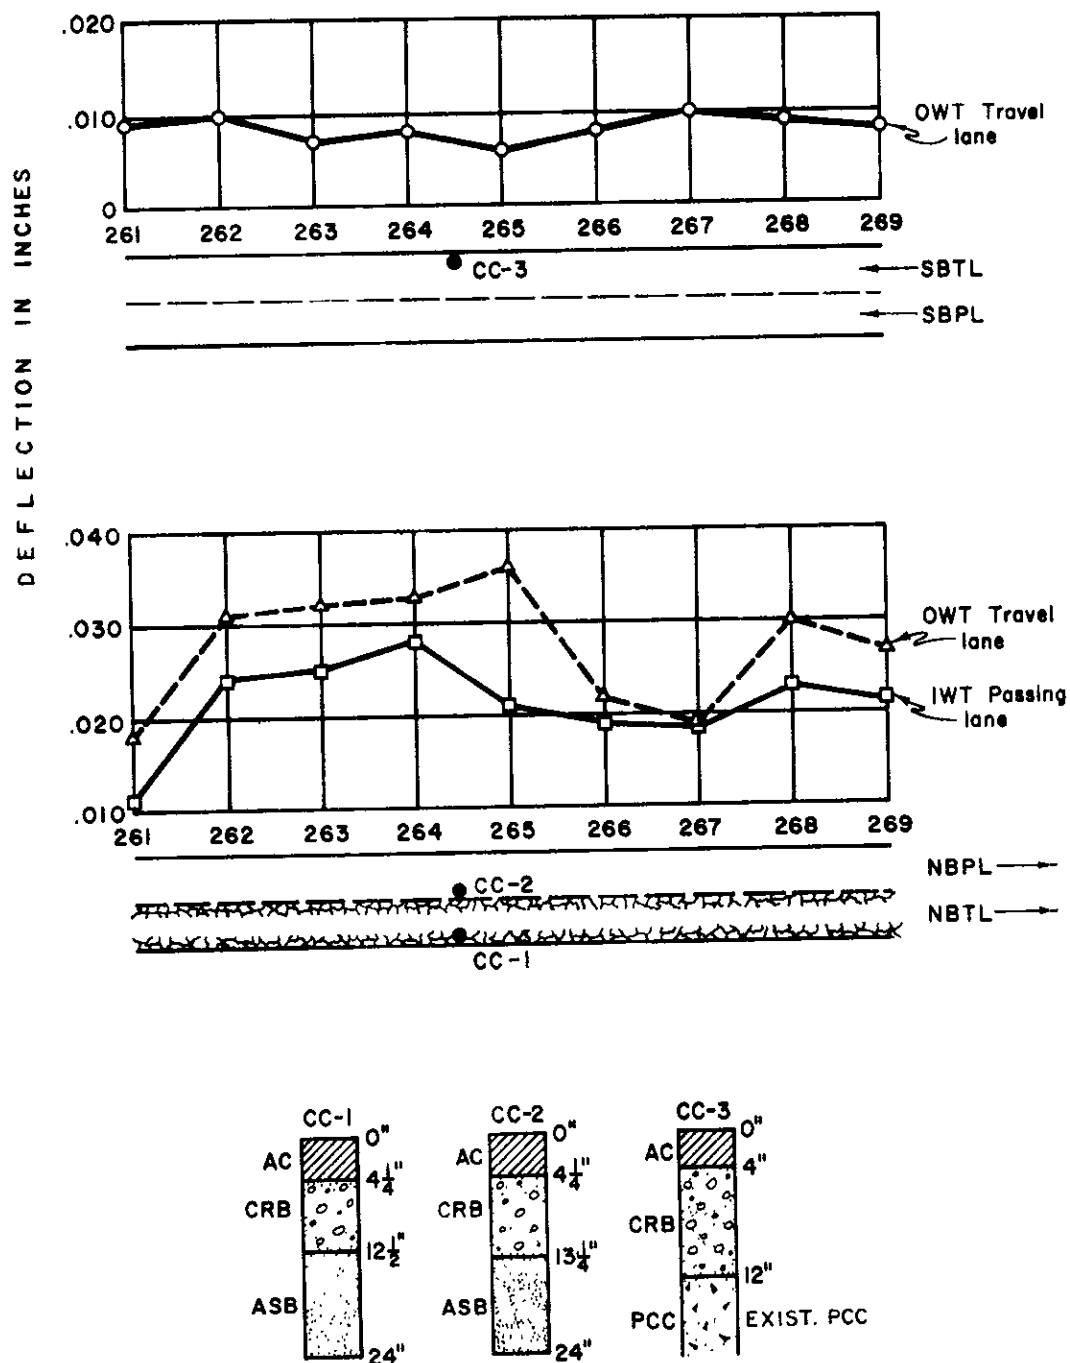
FIGURE 2

The new construction (including the two 4.5' widening strips on both sides of the old PCC pavement) consisted of a 2½" A.C. surfacing over 6" of aggregate base over 6" of aggregate subbase. Inspection of the roadway revealed that virtually all visible distress is confined to the all new construction. This distress is in the form of scattered hairline cracks predominantly in the outer wheel track. To provide the basis of comparison, samples were taken at two locations, in the inner wheel track over the cushion section and in the directly adjacent outer wheel track consisting of all new construction. The core logs, deflection measurements, and results of the condition survey for each location are shown in Figure 2.

STATE OF CALIFORNIA
DIVISION OF HIGHWAYS
MATERIALS AND RESEARCH DEPARTMENT
PROJECT CORING LOCATIONS,
AREAS OF DISTRESS DEFLECTIONS
V SBt -2-B, A
Sta. "B" 261+00 to 269+00

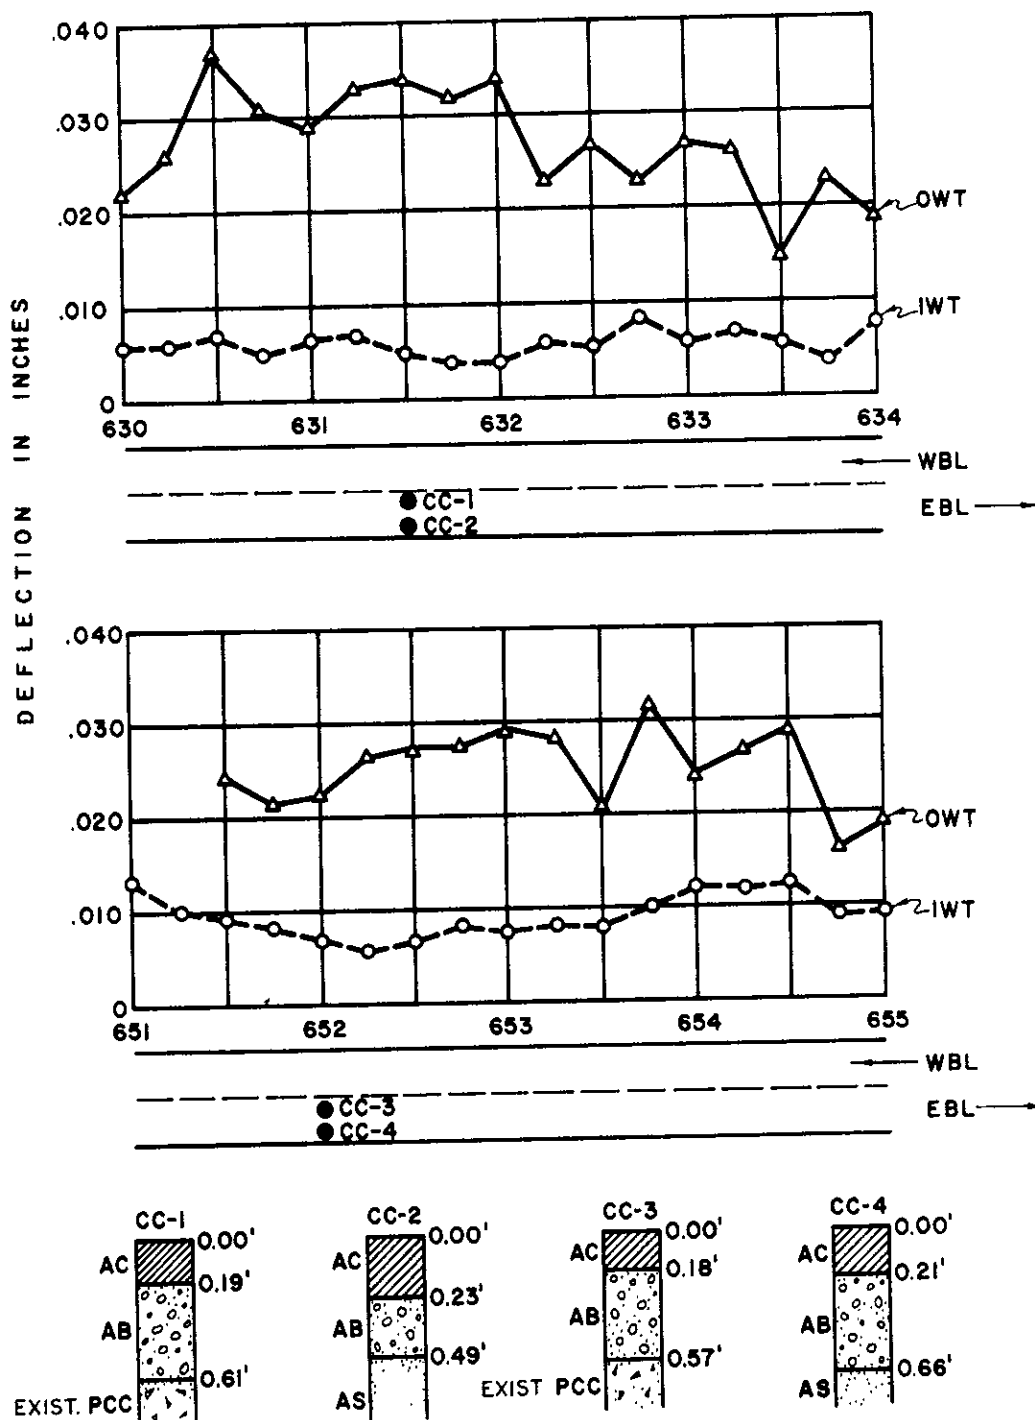
STATE OF CALIFORNIA
DIVISION OF HIGHWAYS
MATERIALS AND RESEARCH DEPARTMENT
**PROJECT CORING LOCATIONS,
AREAS OF DISTRESS DEFLECTIONS**
X STA, TUO-13-B, A
Sta. 630 to 634 and Sta. 651 to 655
